HEALTH HAZARDS OVERCOME IN AGED CARE FACILITY

April Showers Waterproofing was recently commissioned to detail and repair damage to bathrooms in two aged care facilities that had damage occurring due to failed waterproofing installations.

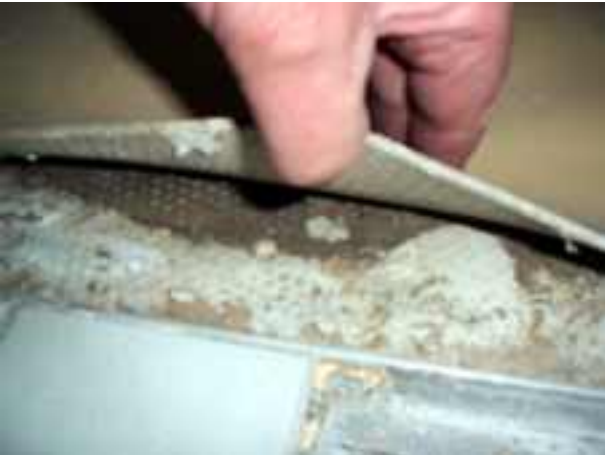
ACRYLIC MEMBRANE

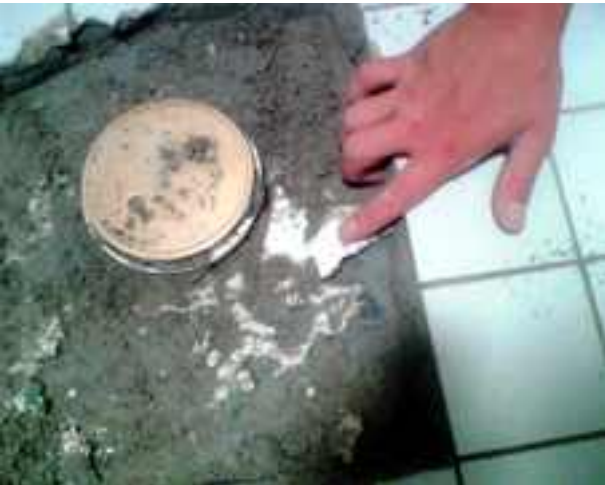
NAIL THROUGH WATER SERVICE
